IX. DEPARTMENT OF PARKS AND RECREATION (DPR) 523 FORMS

DPR FORMS FOR GROUP 3C:

**APE Map Ref # 1-3C, 1401 Monterey Road to APE Map Ref # 11-3C,
409 Garfield Avenue**

Historic Property Survey Report for the SR 710 North Study, Los Angeles County, California, California Department of Transportation District 7, EA 187900, EFIS 0700000191, 2014

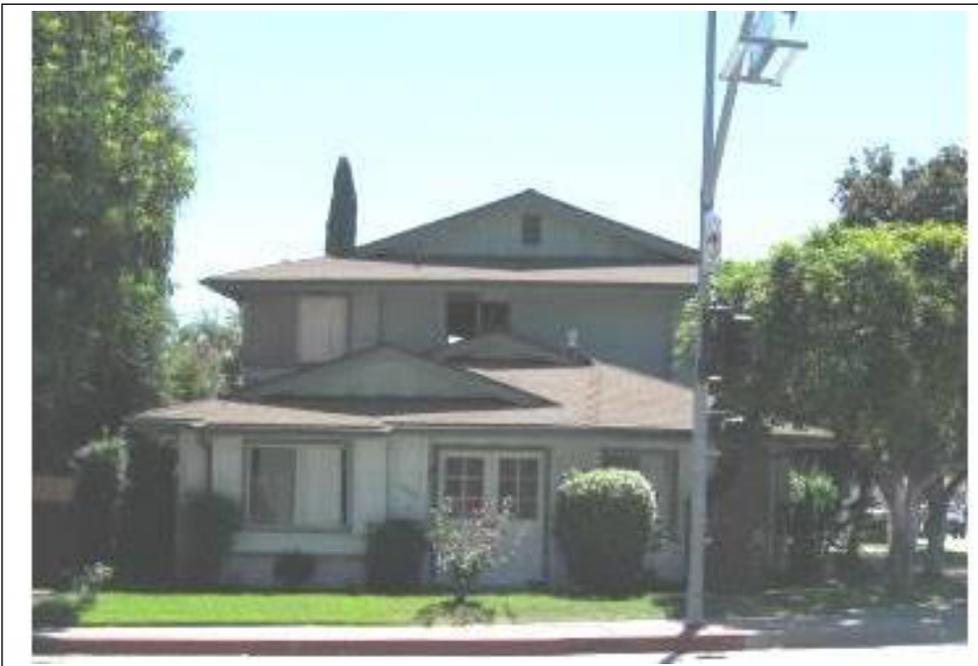
P5a. Photo or Drawing (Photo required for buildings, structures, and objects.)

<p>Architectural Style: Ranch Siding/Sheathing: stucco, All Visible Siding/Sheathing: horizontal boards, N Roof: gable-on-hip, medium, multiple rooflines, wide eaves Fenestration: aluminum, horizontal sliding, front, side, rear Primary Entrance: front Plan: irregular No. Stories: 2 Property Type: residential</p>	<p>Retains integrity: high, setting, location, materials, workmanship, association, design, feeling</p>
--	--

(View, data, accession #)
 View to the S, 09/04/13

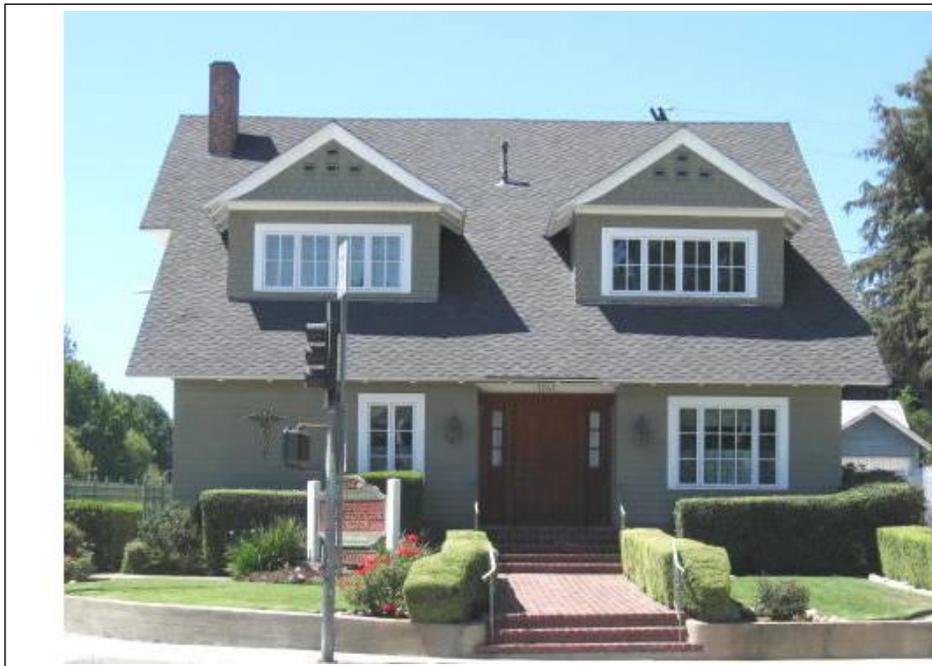
P5a. Photo or Drawing (Photo required for buildings, structures, and objects.)

<p>Architectural Style: Craftsman Siding/Sheathing: wood: clapboard, all visible Siding/Sheathing: wood: shingles, all visible Roof: side gable, steep, exposed rafter tails, other, dormers Fenestration: wood, casement multi-paned, front, side Primary Entrance: front, single door, side lights Other notable features: residence now used as an office, dormer windows and doors have been replaced, and porches have been enclosed. Plan: rectangular</p>	<p>No. Stories: 2 Property Type: residential Retains integrity: medium, setting, location, workmanship, association, design, feeling</p>
---	---

(View, data, accession #)
 View to the W, 09/04/13

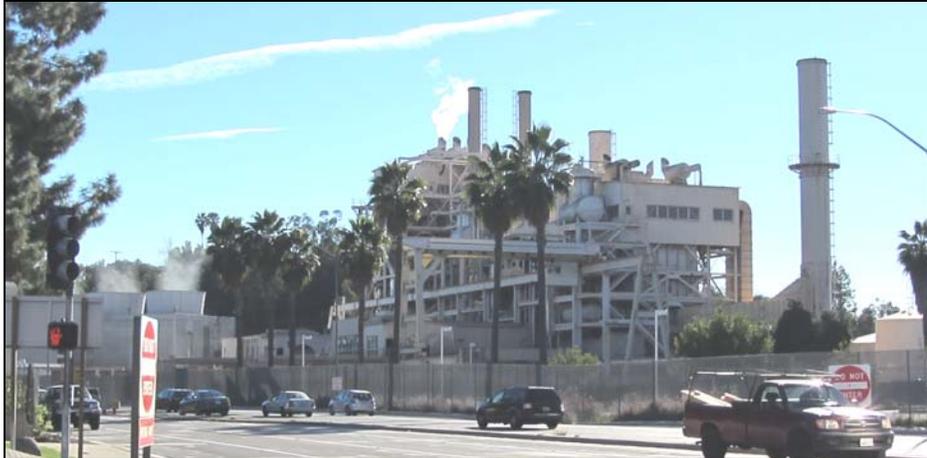
***P5b. Description of photo:** View facing southwest at north/east elevations, January 17, 2015

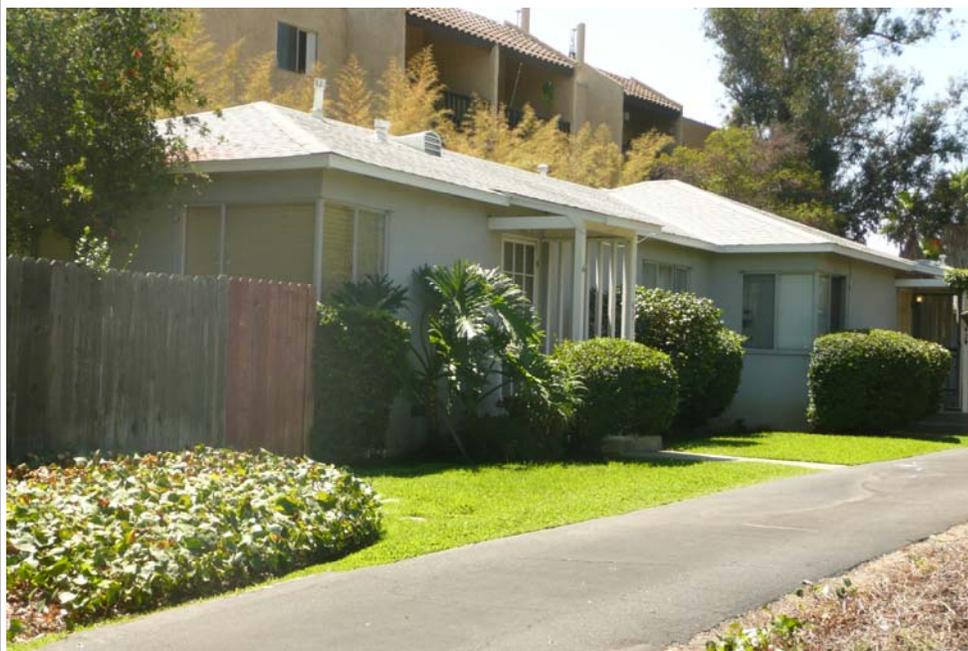
P5a. Photo or Drawing (Photo required for buildings, structures, and objects.)

This one-story Minimal Traditional triplex includes elements of the International style and rests on a concrete slab foundation. The ground plan is irregular and linear, along an east-west major axis with unit 429B, with a hipped pyramid roof, at the west end. The hyphen connecting the unit at the west end to the other two units at the east end is hipped with a ridge. The two east wings are hipped pyramids. The roof is sheathed with grey composition shingles. The exterior walls are clad with stucco. The north-facing, asymmetrical façade includes metal-framed, fixed and corner windows and small entry porches and single, wood doors for each unit. The porches face north and are supported by posts and beams with additional posts to the right of the entry for decorative effect. There are no apparent alterations since the 1958 additions.

P5b. Description of Photo: (View, date, accession #) Façade, view to the southwest (8/30/14)

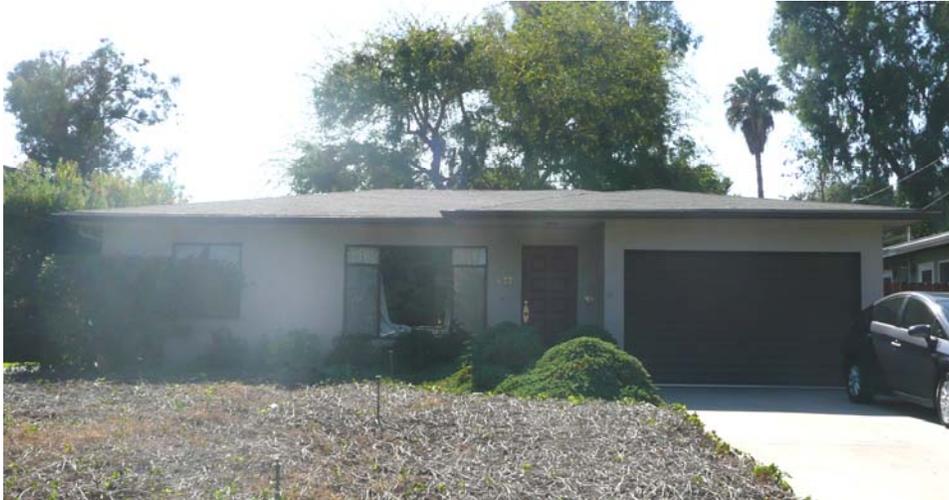
P5a. Photo or Drawing (Photo required for buildings, structures, and objects.)

*P3a. Description: (Describe resource and its major elements. Include design, materials, condition, alterations, size, setting, and boundaries)
This one-story Ranch style residence is located on the west side of Garfield Avenue east of the Pasadena Freeway. It is rectangular in plan and rests on a concrete slab foundation. It is surmounted by a moderately-pitched, cross-hipped roof sheathed with composition shingles and has moderate eaves. The exterior walls are clad with stucco. The asymmetrical, east-facing façade includes a wood-framed windows, an off-center entry with a single wooden door, and an attached garage. There are no apparent alterations.

P5b. Description of Photo: (View, date, accession #) Façade, view to the west (8/30/14)

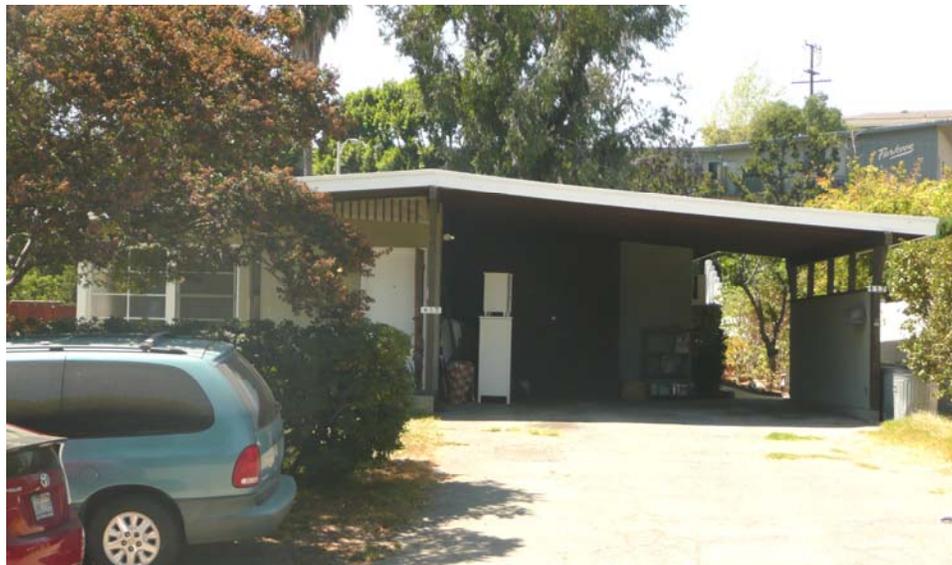
P5a. Photo or Drawing (Photo required for buildings, structures, and objects.)

*P3a. Description: (Describe resource and its major elements. Include design, materials, condition, alterations, size, setting, and boundaries)
This one-story, Modern style duplex is located on the west side of Garfield east of the Pasadena Freeway. It has a rectangular plan and rests on a concrete slab foundation. It is surmounted by a low-pitched, front-gable roof sheathed with asphalt and gravel and has moderate eaves. The exterior walls are clad with stucco. The asymmetrical, east-facing façade includes vinyl-framed windows, a wooden door, and an attached carport. The residence retains a fair degree of integrity with the only obvious alterations being the vinyl-framed windows.

P5b. Description of Photo: (View, date, accession #) Façade, view to the west (8/30/14)

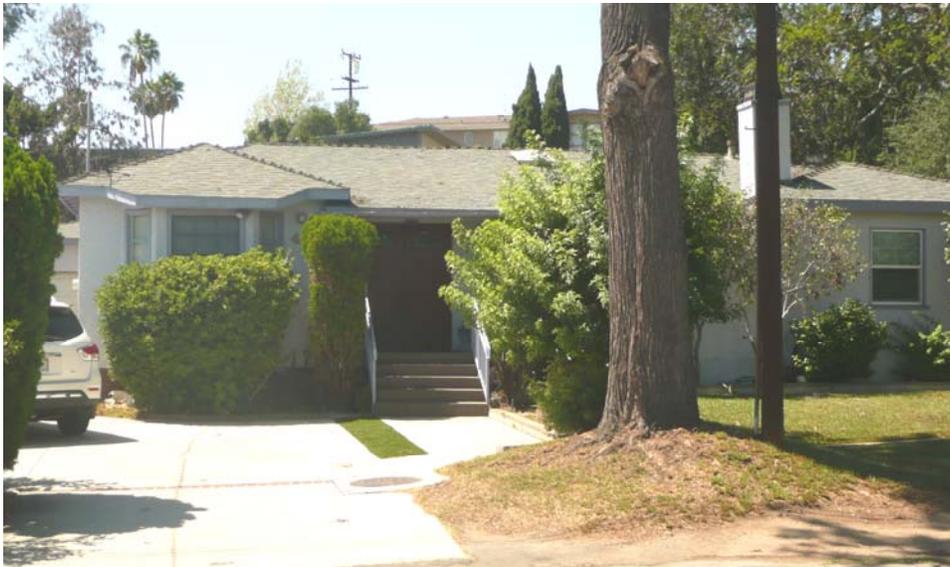
P5a. Photo or Drawing (Photo required for buildings, structures, and objects.)

*P3a. Description: (Describe resource and its major elements. Include design, materials, condition, alterations, size, setting, and boundaries)
This one-story Ranch style residence is located in a residential area east of the Pasadena Freeway. It is rectangular in plan and rests on a concrete slab foundation. It is surmounted by a moderately-pitched, cross-hipped roof sheathed with composition shingles and has narrow eaves. The roof also features two skylights and a chimney. The exterior walls are clad with stucco. The asymmetrical, east-facing façade includes wood-framed, double-hung windows, a bay window, and a pair of wood and glass doors accessed by five concrete steps. The property also includes a detached garage. There are no apparent alterations.

P5b. Description of Photo: (View, date, accession #) Façade, view to the west (8/30/14)

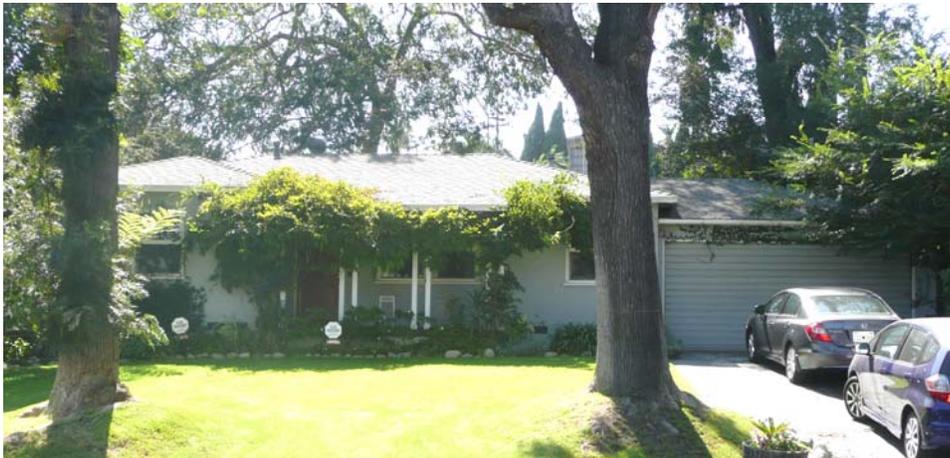
P5a. Photo or Drawing (Photo required for buildings, structures, and objects.)

***P3a. Description:** (Describe resource and its major elements. Include design, materials, condition, alterations, size, setting, and boundaries) This one-story Ranch style house is located in a residential area east of the Pasadena Freeway. It is rectangular in plan, rests on a concrete slab foundation, and is surmounted by a low-pitched, hipped roof sheathed with composition shingles. It has narrow eaves and the walls are clad with stucco. The east-facing, asymmetrical façade includes several wood-framed, double-hung windows, a small entry porch, a single, wooden door, and an attached garage. The property features mature trees and a river rock stones in place of a formal curb. There are no apparent alterations.

P5b. Description of Photo: (View, date, accession #) Façade, view to the west (8/30/14)
